Seismic Evaluation of Traditional Timber Structures in Taiwan

Tsai, Pin-Hui

A Thesis Submitted for the Degree of Doctor of Philosophy

University of Bath

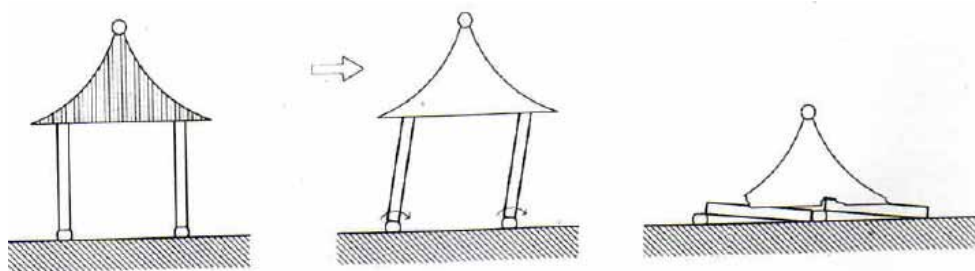
Figure 3.2.3 Collapse of building (Hung et al, 2002)

Huang and Sheu (2001) classified the damage of timber and bamboo buildings by their architectural elements, assuming seven parts form the building: column, purlin, beam, Dou-Gon joints set, mud and timber interior wall, roof and eave part. They stated that the failures of Dieh-Dou building were mainly caused by the weight of the roof compared with the lightness of the lower portion of the building that led to large lateral sway during horizontal earthquake load (Fig. 3.2.3); the tiny joint between wooden column and stone podium would, therefore, be considered as a pin, rather than a restrained base (Fig. 3.2.4).

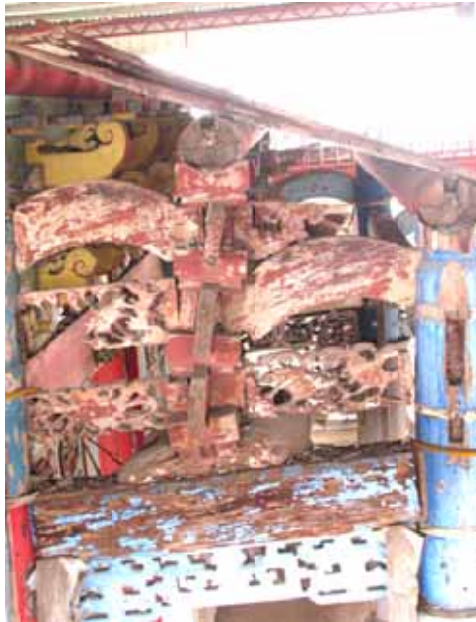
Figure 3.2.7 Deformed Dou-Gon set and elements pull out

The Dou-Gon joint set is easily deformed by a horizontal force, but its deformed shape is different to that of a continuous column (see Fig. 3.2.6). On the left of the diagram is shown the deformed shape under a horizontal force of a continuous column, whilst the right side shows the type of deformed shape of a joint set, which can be considered as a stack of small columns. The Dou-Gon joint set of the Guan-Shi temple displayed this kind of deformed shape (see Fig. 3.2.7). Furthermore, the in plane pieces which connect with the Dou-Gon joint sets are likely to pull out because of the horizontal force and the leaning of the bracket set.

The roof ridges of temples are full of heavy decorations (see Chapter 2), which are placed on the roof and lack strong connections with the main structural elements of the temple; hence under vibration these ridge decorations easily fall down. These failure modes are classified as damage Level 2 in the sense that while each of them

cannot trigger structural failure, if a significant number of elements pull out, the structure global integrity is substantially impaired and collapse can be accelerated. Also, falling pieces of very heavy roof decorations are a threat for human life.

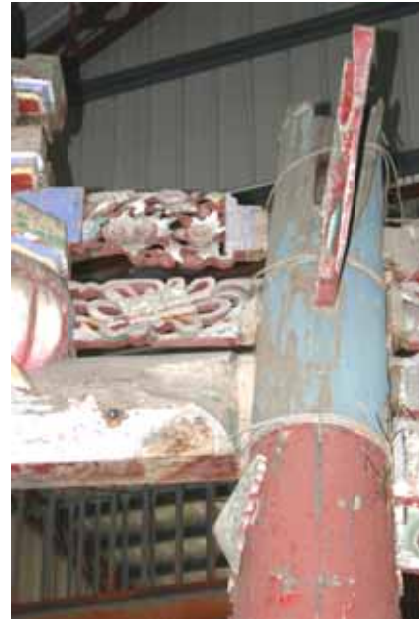
Figure 3.2.8 Beams pull out from column

Other joints damaged by the earthquake were the connection between horizontal and vertical structural elements, for example, the joints between column and beams. Fig. 3.2.8 show beams pulled out from columns in the Guan-Shi temple. The photo shows that the joint of beam is a simple straight tenon, weak against lateral force and easily pulled out.

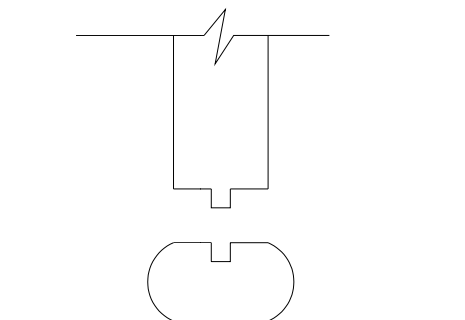
Figure 3.2.10 Connection of column

In order to isolate the wooden columns from ground humidity and avoid decay, stone podiums or half stone columns are placed between the columns and the ground. These joints represent a weak point under earthquake loading. The connection of the podium stone and the timber column is tenon (wood) and mortise (stone); Fig. 3.2.10 shows the section of a wooden column and stone podium, which forms the foundation, while Fig. 3.2.11 shows the tenon of a timber column. As can be seen, generally the length of the tenon is small compared to the whole column length; during a strong earthquake with high horizontal and vertical acceleration this tenon is subjected to rotation or even sliding if the shear is higher than the timber tenon capacity, Fig. 3.2.12 shows an example of column rotated.

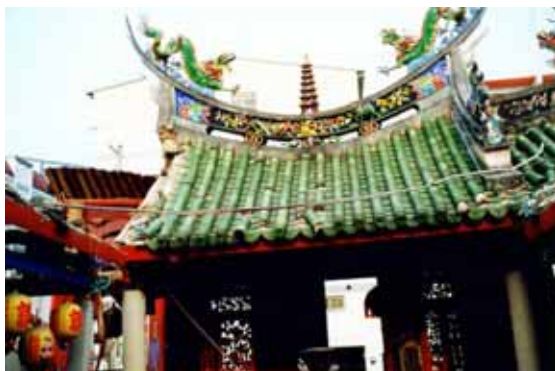
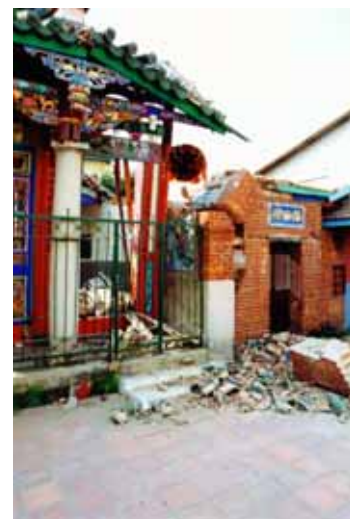
Figure 3.2.14 Failure of the secondary spaces De-Shin temple (photo taken by Tseng)

Masonry walls provide little resistance to earthquake load and fail easily during sustained vibration; according to Chang et al (2002) there is only surface friction between purlin and masonry wall to resist relative movement; once the horizontal force is greater than the frictional resistance the purlins can pull out from the masonry. When the masonry wall of Dieh-Dou building falls, this can lead to a total failure of the roof in the secondary spaces, while the main space is still standing (see Fig. 3.2.13). De-Shin temple is an example of this type of failure, see Fig. 3.2.14.

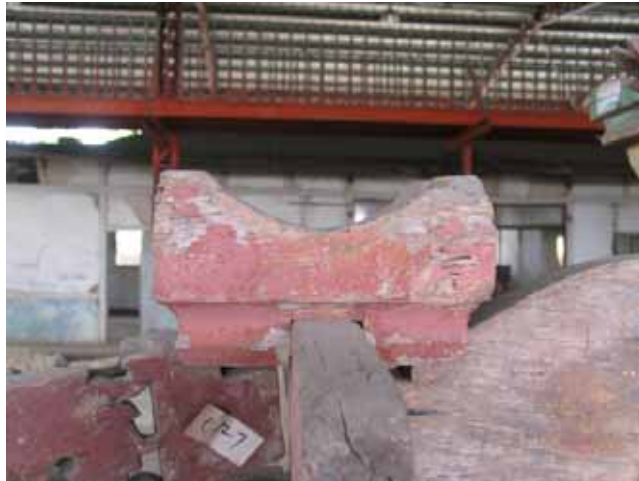
Figure 3.2.15 Upper Dou saddle, seating for the purlin

Once the frames are disconnected from masonry walls, the two frames become vulnerable and easy to rotate and deform. The purlins are placed on the top of the Dou, shaped like a saddle, but without tenon and mortise, see Fig. 3.2.15. Under seismic load, they can also fall down and separate the two frames; in this case, the structure is likely to collapse out-of-plane, as the frames no longer have stabilizing weight from the roof.

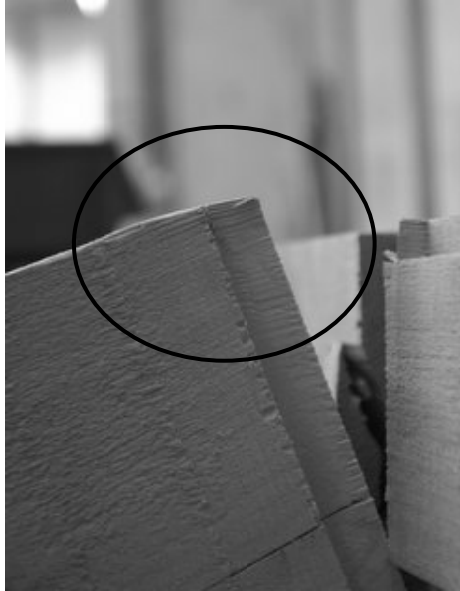
During loading two types of mechanical failures occurred. First, localized stresses occurred on the surface where the beam (Part 8) contacts with the upper Dou (Part 5). The top edge of beam was crushed due to the upper Dou providing restraint to the beam movement. Figure 4.3.7 shows the crushed fibres of top edge of beam

Figure 4.3.7 Crushing of top edge of beam

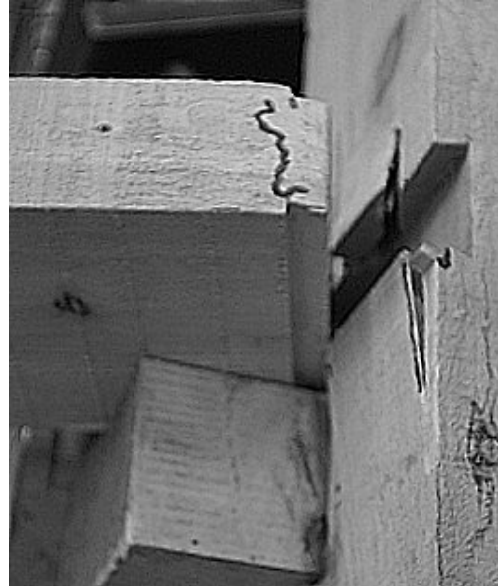
and Figure 4.3.8 shows a view from top, where the crushed part of the beam is shown and a vertical crack is highlighted.

Figure 4.3.8 Crack highlighted by pen mark

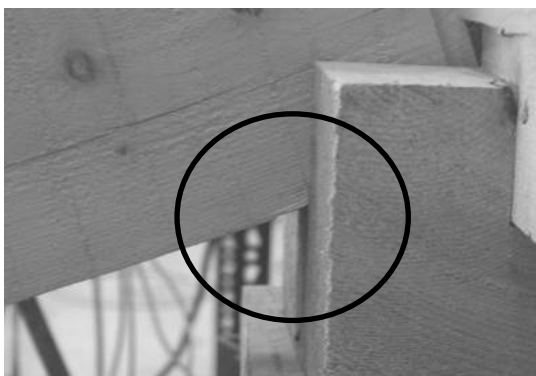
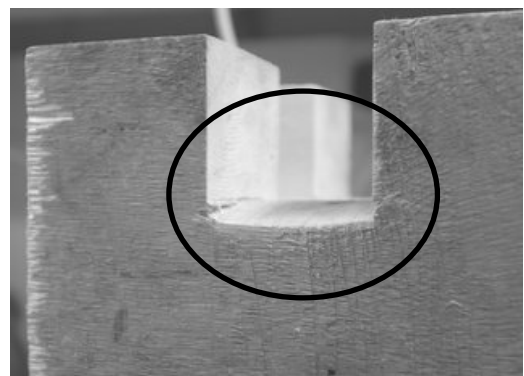
Since the beam (Part 8) has deformed downward under jack loading, local deformation occurred in the lower part of the joint in contact with the lower Dou (Part 9), see Figure 4.3.9. However, as the in plane beam (Part 8) has a dove-tail connection with the continuous out of plane beam (Part 6, see Figure 4.2.6), a second type of failure occurred involving the ripping off of the dove-tail as the upper part of the beam tended to pull-out.

Figure 4.3.9 Local deformation of beam (Part 8) and lower Dou (Part 9)

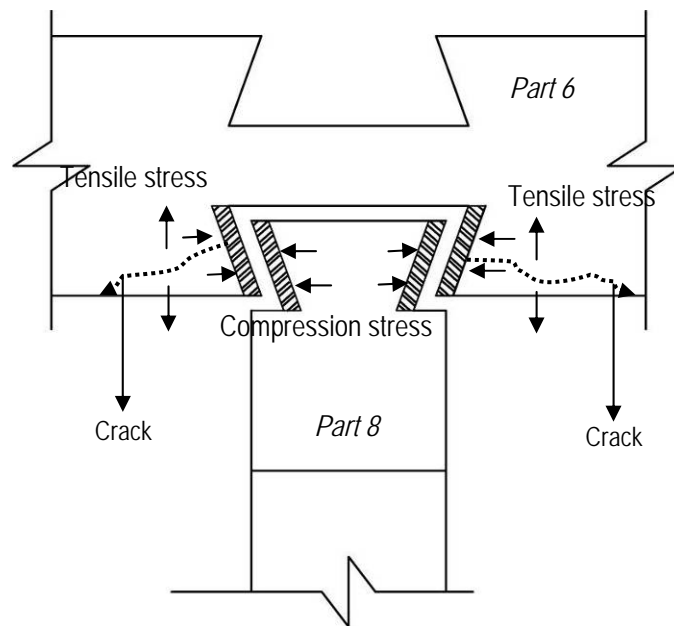
Figure 4.3.11 shows a horizontal section of a dove-tail between the in plane (Part 8) and out of plane beams (Part 9), where compression and tension stresses develop on the contact surfaces. In the physical test, see Figure 4.3.12, the tensile capacity of the fibres in the dove-tail of the out of plane beam (Part 6), where the stress is perpendicular to the grains, was exceeded and this initiated the failure mechanism. In the material tests discussed in the previous section it has been found that that tension strength perpendicular to grain is only 1.5MPa, confirming that the dove-tails subjected to tension are the weakest part of the joint.

Figure 4.3.11: Stresses in the dove-tail joint

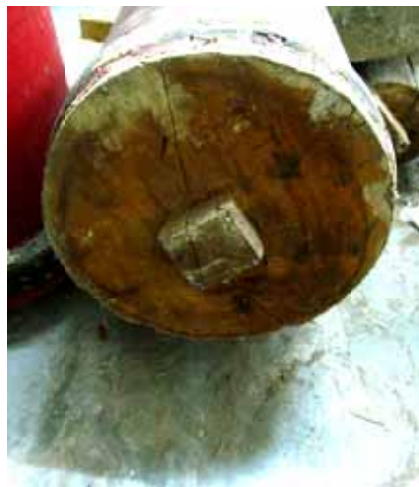
Figure 5.2.2 is the close up of a tenon of a timber column that would insert into the stone podium. Compared to the size of the column, the tenon is very small revealing the weakness of the joint.

Figure 5.2.2 Tenon of column

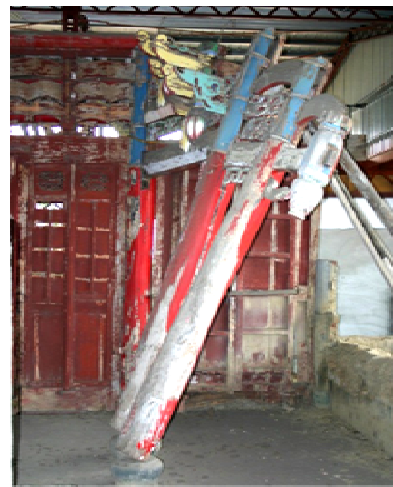
Figure 5.2.3 Rotation of column

Huang & Sheu (2001) studied the failure modes of Dieh-Dou buildings through observation after the 1999 Chi-Chi earthquake and showed that the wooden columns could easily sway (see Fig. 5.2.3, showing a frame with no purlins on top) as they only have such a tiny joint with the stone podiums. Therefore, the joint is likely to behave almost as a spherical hinge without any rotational constraint and it is hence modelled releasing the rotational degrees of freedom (d.o.f.) of the node to ground of the columns. On the other end post-earthquake survey also shows that the tenon of the columns does not shear off, and hence it is effective in providing translational constraint between the column and the stone podium, and hence the translation d.o.f. are set to fix. In the Dieh-Dou buildings, the floor is paved by stone or brick and the stone podiums are fixed upon them. The survey shows that the podiums normally remained in position after earthquake, thus the stone podiums in FE model of Dieh-Dou frame were ignored and treated as part of the rigid support.

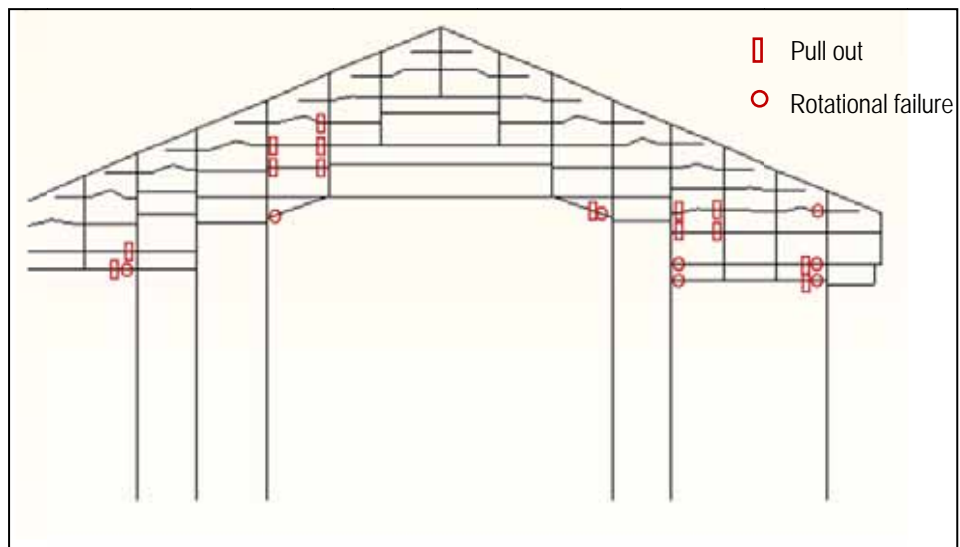
Figure 6.5.10 Joint failure of DS-LF 2

The results of these two models are very similar, in terms of roof apex lateral displacements and numbers of joints failures. The patterns of failure in both

analyses (Fig. 6.5.9 and Fig. 6.5.10) show that Zone C is more vulnerable than Zone A and the central part Zone B. The two bracket supports under the first main beam (Fig. 6.5.1) are damaged in both analyses. The binding beams connecting columns 3 and 4 with the first series of Dou-Gon joints are failed in DS-LF 2 and DS-LF 1 respectively.

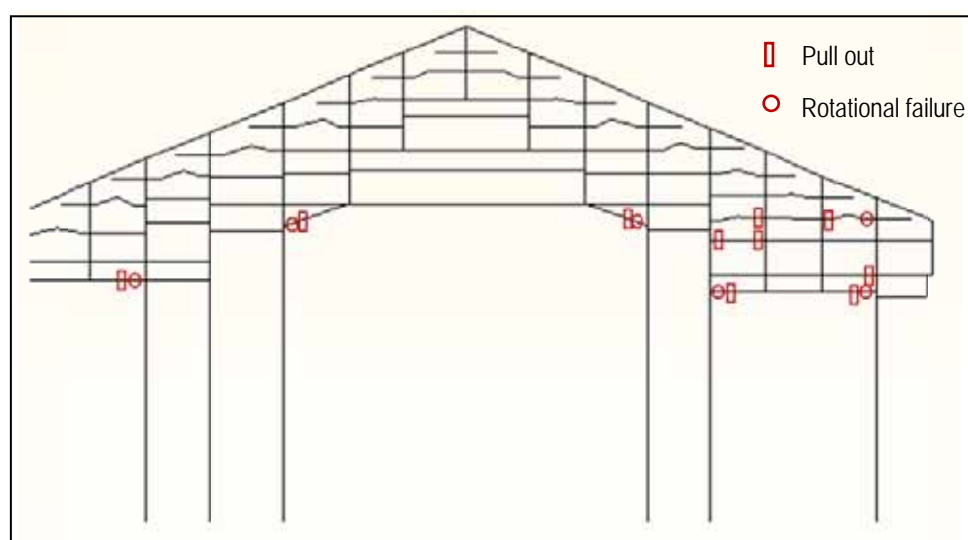
Figure 6.5.12 Joint failure of response spectrum of Dou-Shan main hall

There is no material failure in the response spectrum but 10 joint pull out and 6 rotational failures were found, see Fig. 6.5.12. The total numbers of joint failures are also lower than DS-LF 1 and DS-LF 2, but the difference is not large.

In the central zone B, response spectrum model (DS-RS) also correctly predicts the failure of the inclined supporting brackets. Zone C2 shows more joint failures than other zones, confirming the lateral force analysis and matching post earthquake observation.

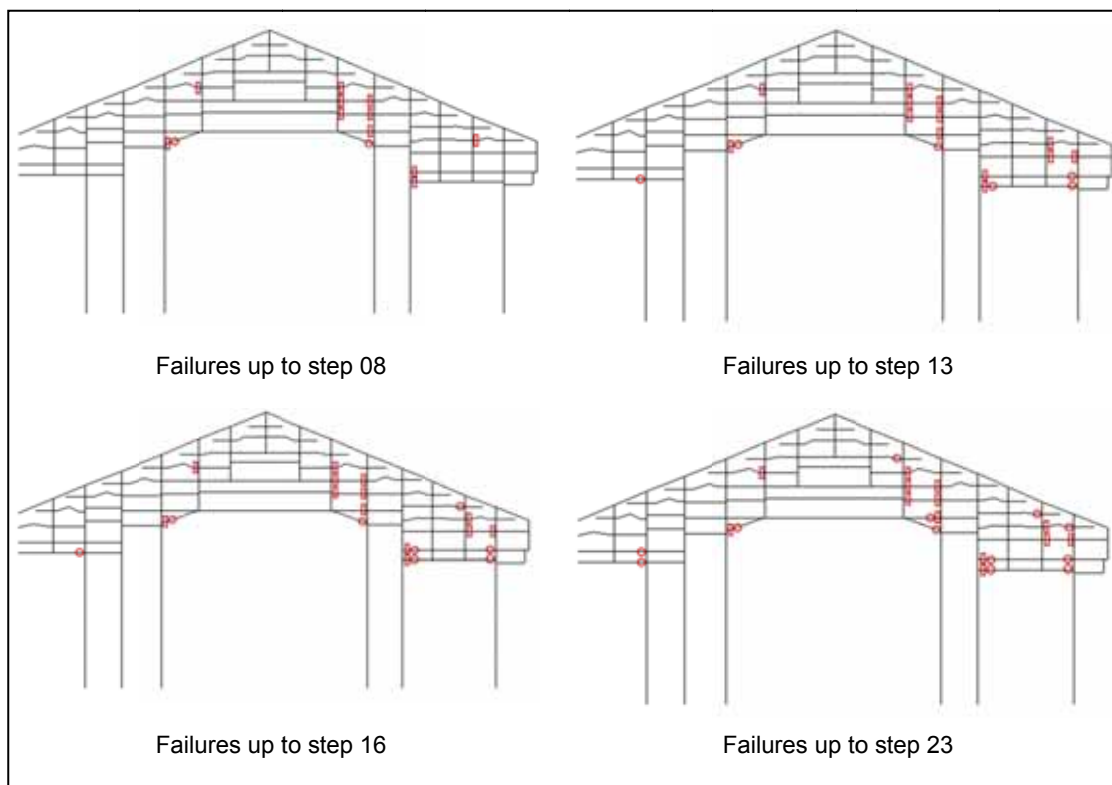
Figure 6.5.14 Failures up to step 08, 13, 16 and 23

At step 08 (Fig. 6.5.14), which is the last step where lateral equivalent acceleration was $0.099g$, 6 out of 9 failures are the same as observed in the real right frame (Fig. 6.5.2). At steps 13 and 16, equivalent to $0.198g$ and $0.231g$, respectively, the resulting failures are already similar to those in the post-earthquake observation, where support elements (1 and 2) located between the first main beam and columns 3 and 4 are damaged in the FE model and in reality. This step by step analysis also catches failures of the C2 corridor beam, the binding element on C2 zone and binding element linking the Dou-Gon joint set 5 with column 4. At step 23, the last one, for a total displacement of 96 mm, more failures appear, such as the A1 corridor beam and one binding beam between joint sets 4 and 5.

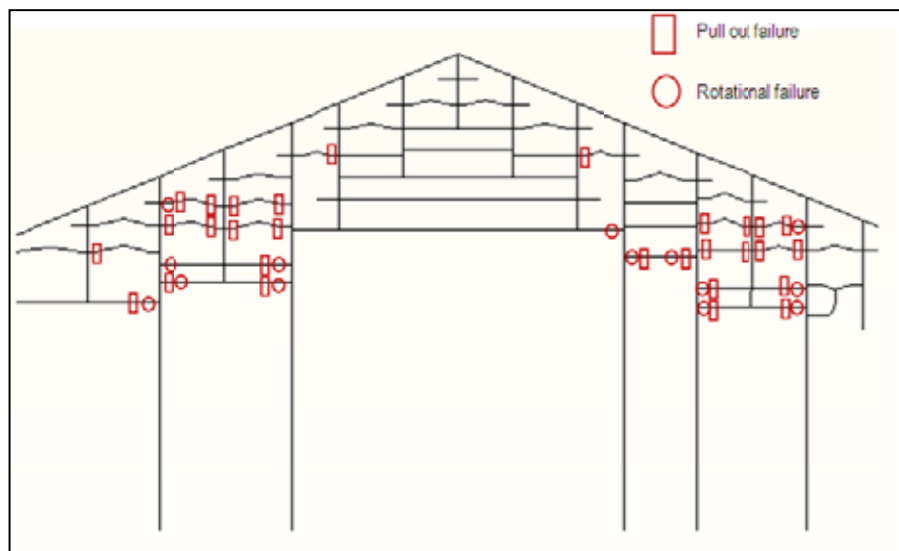
Figure 6.6.4 Result of check (ii)

They both show that the effects of the vertical excitation component on the frames are negligible, as check (ii) results in only one additional failure out of forty-two encountered with the horizontal force only, while check (iii) results in too fewer failure to be realistically comparable with the in situ survey. These checks prove correct the hypothesis that vertical load can be neglected.

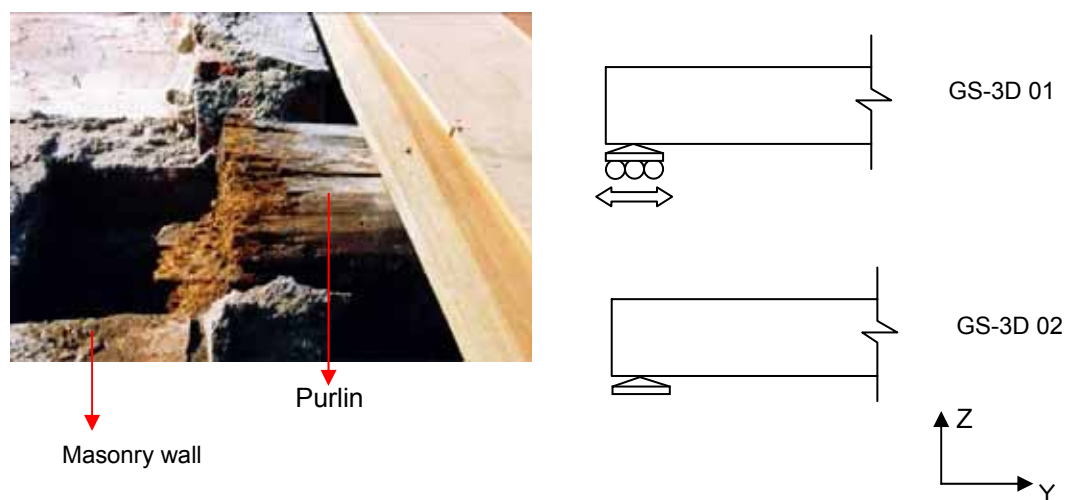
Figure 6.6.7 Purlin connection with masonry wall

Purlins of Dieh-Dou buildings are simply supported onto the masonry walls without a specific tension resisting connection. Also, Taiwan is in a high humidity climate zone and the end of timber purlins sitting on the top of masonry are often found rotted (Fig. 6.6.7). Therefore, the purlins would rely at best only on friction with the wall to resist the pull out force due to an earthquake component along Y. Hence, the two models simulate the two possible extremes of the restraint condition, i.e. free movement (GS-3D 01) or restrained movement (GS-3D 02) in Y direction. Also, no restraint to rotation was assumed for the purlins at both connection with the masonry and the top of the frames.

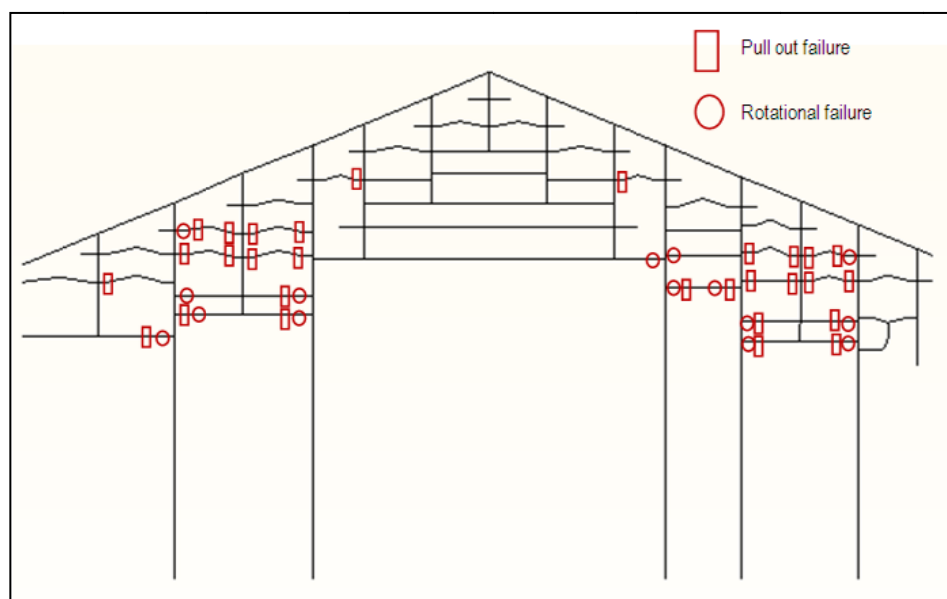
Figure 6.6.9 Failure of GS-3D01 model

The frames are then checked for the joint failure and material failure criteria, considering the biaxial bending and shear in the interaction formula of the material failure criteria. Although there is an increase in the timber stresses especially in the columns (as expected), still no material failure are found, with the most stressed elements being at around 55% of the characteristics strength. The pattern of joint failures is exactly the same that in the single frame, with only two additional joint failure in GS-3D 01 (Fig. 6.6.9) if compared with the single frame response spectrum analysis.

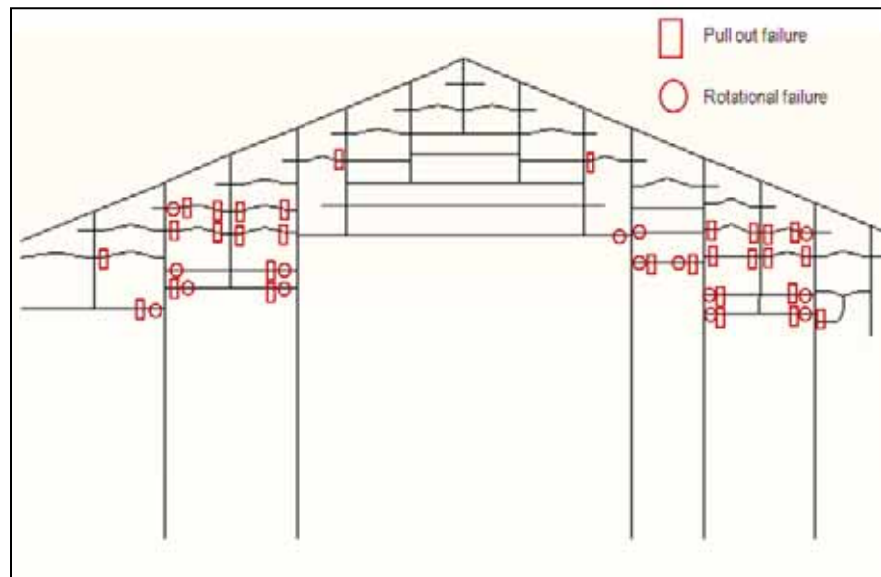
Figure 6.6.12 Failures in GS-3D 03 model

Table 6.5.3 shows the results of the modal analysis, while the shapes of the first two modes are plotted in Fig. 6.6.11 and the joint failure pattern in Fig. 6.6.12 obtained with the response spectrum analysis. All results, including the joint failures, are practically coincident with those of model GS-3D 01, confirming that there are no major differences between 2D and 3D modelling in terms of behaviour of the single frames.

However, in order to avoid collapse of the purlins in between the frames when the frames vibrate in opposite directions (although the present 3D model shows these modes to have an insignificant mass participation in Y direction) it is important that their connection with the top of the frame is as firm as possible. Otherwise, the collapse of the whole building could be initiated by the purlins (and the roof) falling in between the frames, leaving the frames prone to out of plane instability.

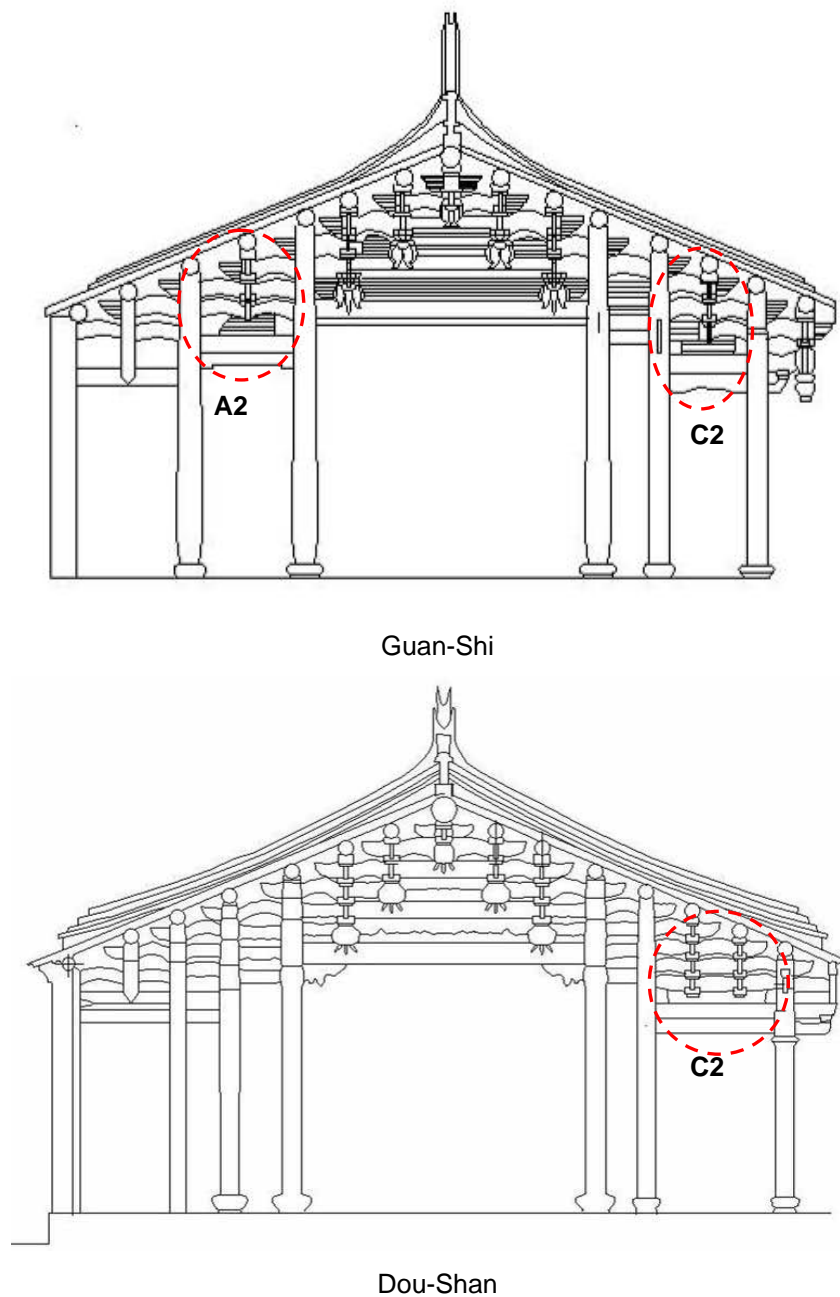
Figure 7.1.1 Elements selected for strengthening

The assessment of the main hall of Guan-Shi and Dou-Shan temples, combined with the survey results, showed that the central parts (zone B) of the frames are intact but the outer parts (zone A and C) are prone to failure. From a heritage point of view the central part (zone B) of the frame is the most important, as there are important paintings on the surface of timber members, while the outer zones are of less significance in this respect. Hence, elements of the zones A2 and C2 of Guan-Shi main hall and C2 of Dou-Shan main hall (Fig. 7.1.1), which contained the great majority of the failed elements, are selected for strengthening.

Considering that timber members of Dieh-Dou frames are a heritage in themselves, the strengthening effort should also be concerned with issues of reversibility. Hence, replacement of timber elements by either timber pieces or other material should be avoided. In order to maximise the retention of historic material and still strengthen the structure so that it is able to safely support earthquake loads, the second option is considered the most appropriate, i.e. supplement the timber with other material.
